Geotechnical Investigation

**SE Reinig Road Embankment Failures
Slope Stability Analyses
Project NO. 1132628**

April 2019

RE: **SE Reinig Road Embankment Failures**
Slope Stability Analyses

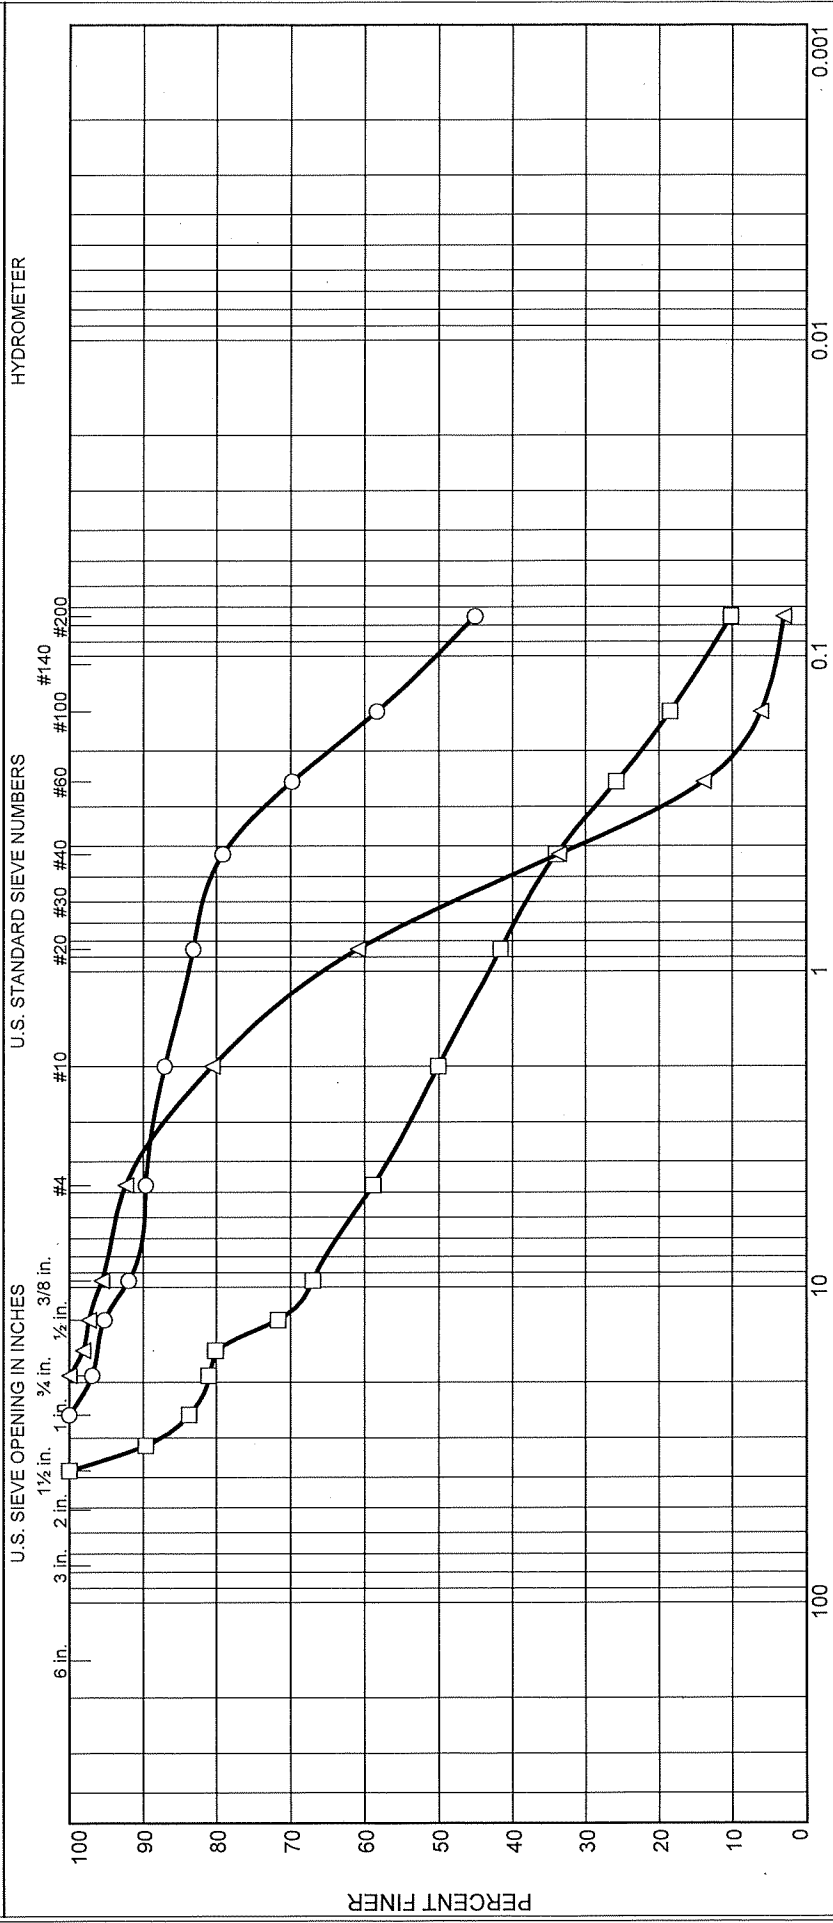
Client King County DNRP		KING COUNTY	
Project Reing Road			
Project No. 1132628	Figure A-5	MATERIALS LABORATORY

Source	Sample #	Depth/Elev.	Date Sampled	USCS	Material Description	NM %	LL	PL
B-1	KC-18-204	7.5'-9.0'	5-30-2018	SM	Silty Sand	19.1		
B-1	KC-18-205	17.5'-19.0'	5-30-2018	SP-SM	Poorly Graded Sand with Silt and Gravel	14.4		
B-1	KC-18-206	25.0'-26.5'	5-30-2018	SP	Poorly Graded Sand	20.0

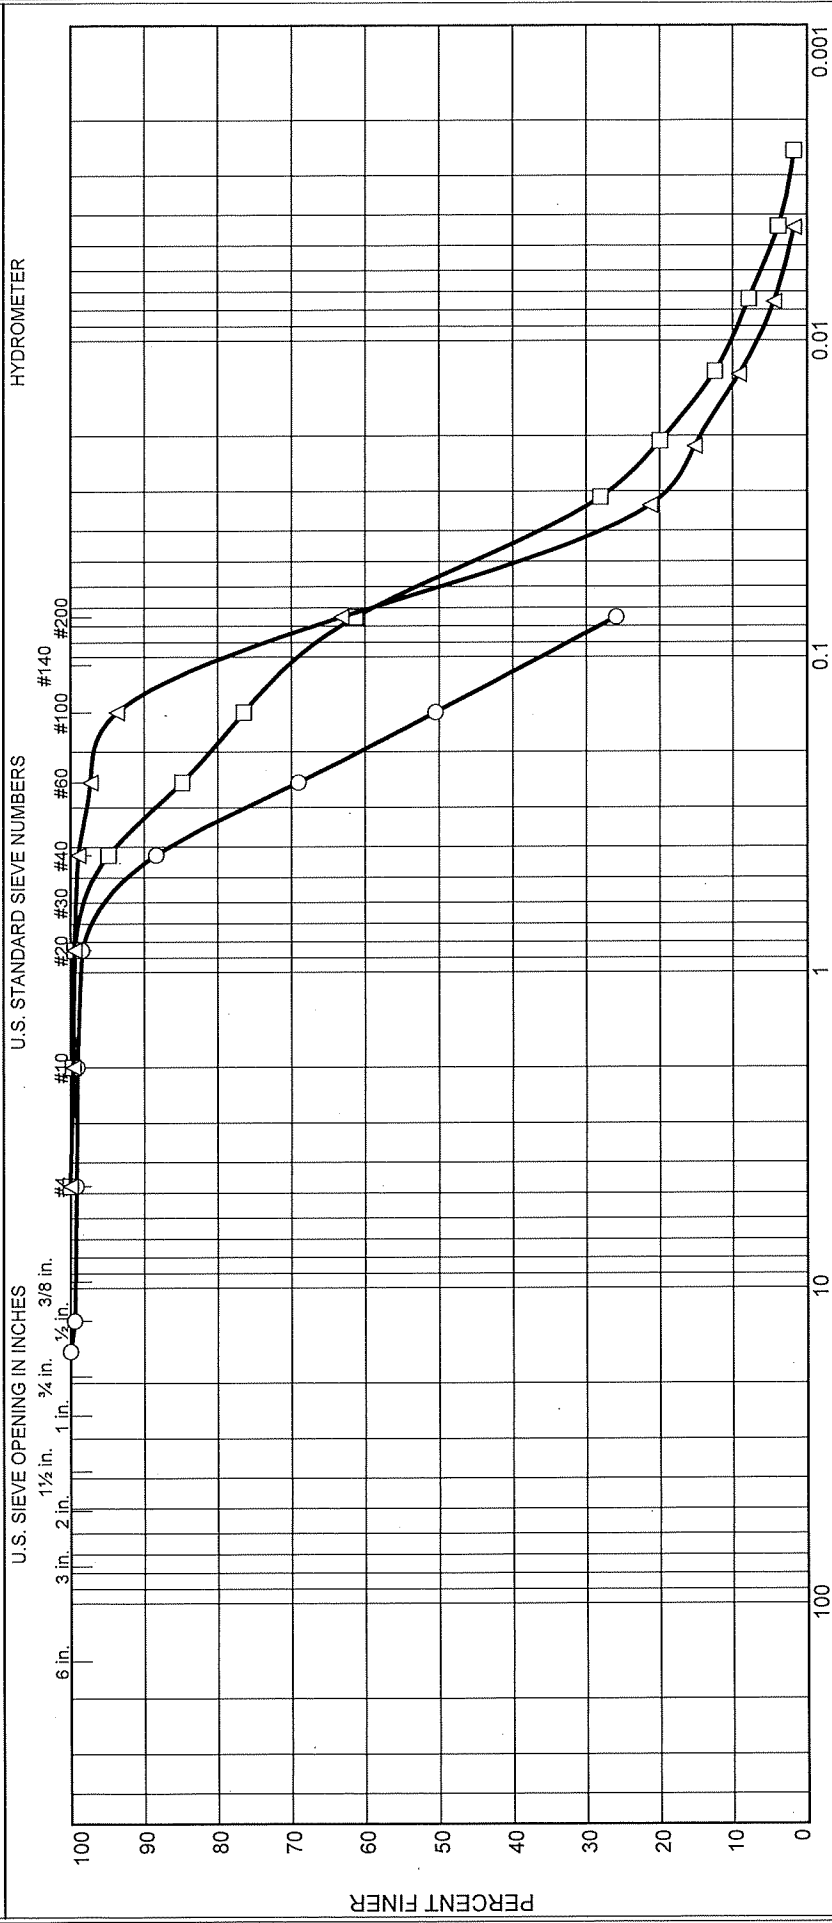
GRAIN SIZE - mm.									
% +3"		% Gravel		% Sand			% Fines		
		Coarse	Fine	Coarse	Medium	Fine	Silt	Clay	
○	0.0	0.0	0.8	0.2	10.6	62.5	25.9		
□	0.0	0.0	0.0	0.4	4.8	33.5	56.6		
△	0.0	0.0	0.0	0.4	0.7	35.7	60.9		
Source	Sample #	Depth/Elev.	Date Sampled	USCS	Material Description				
○	B-1	35.0'-36.5	5-30-2018	SM	Silty Sand				
□	B-1	45.0'-46.5'	5-30-2018	ML	Sandy Silt				
△	B-1	55.0'-56.5	5-30-2018	ML	Sandy Silt				
Client King County DNRP				KING COUNTY					
Project Reinig Road									
Project No. 1132628		Figure		MATERIALS LABORATORY					
		A-6
